CONSERVATION ASSESSMENT

MEMORIAL TO THE START WESTWARD SCULPTURE AND PYLONS MARIETTA, OHIO

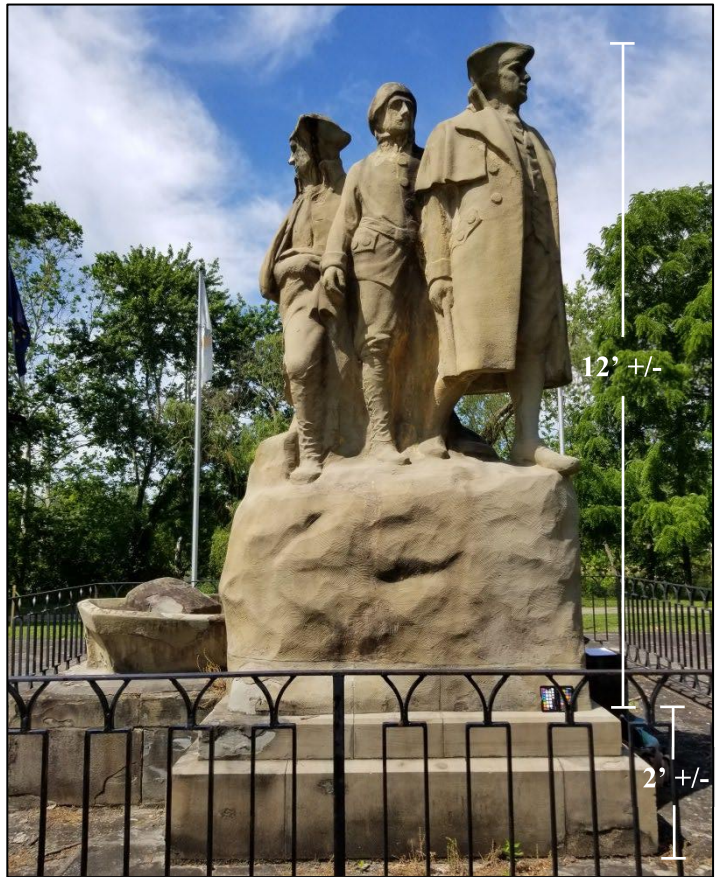
Photo 3: below, right. Sculpture, west elevation; faces the river.

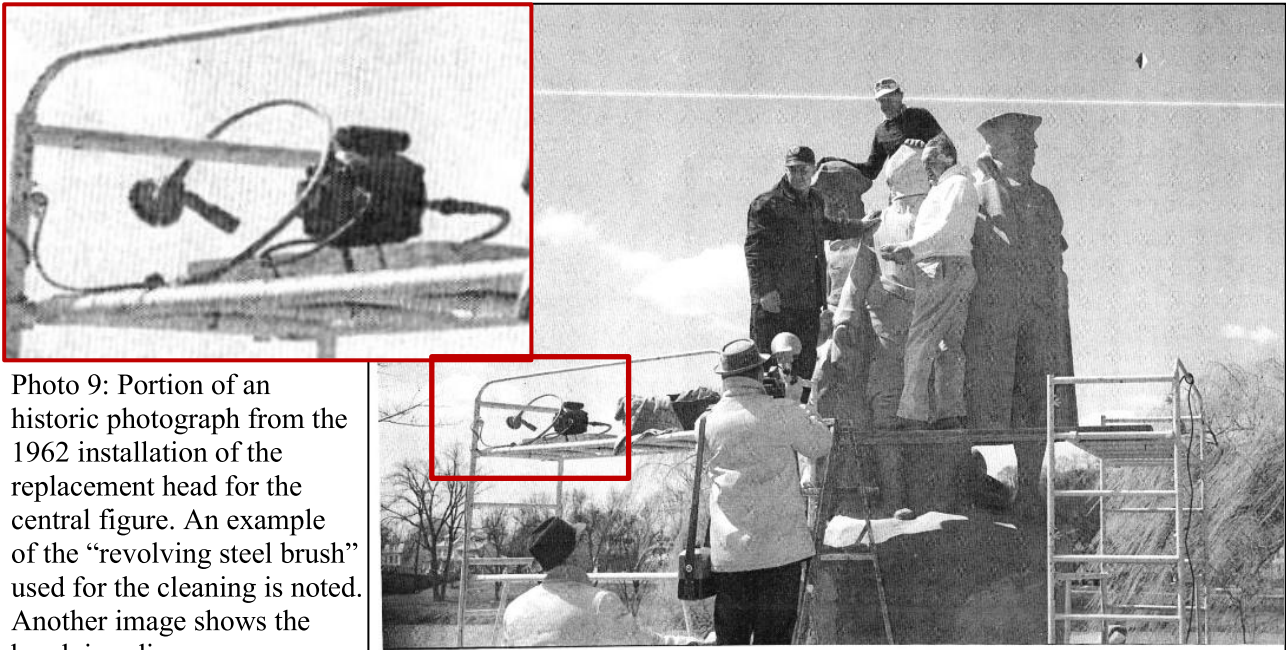
Photo 9: Portion of an historic photograph from the 1962 installation of the replacement head for the central figure. An example of the “revolving steel brush” used for the cleaning is noted. Another image shows the brush is a disc.

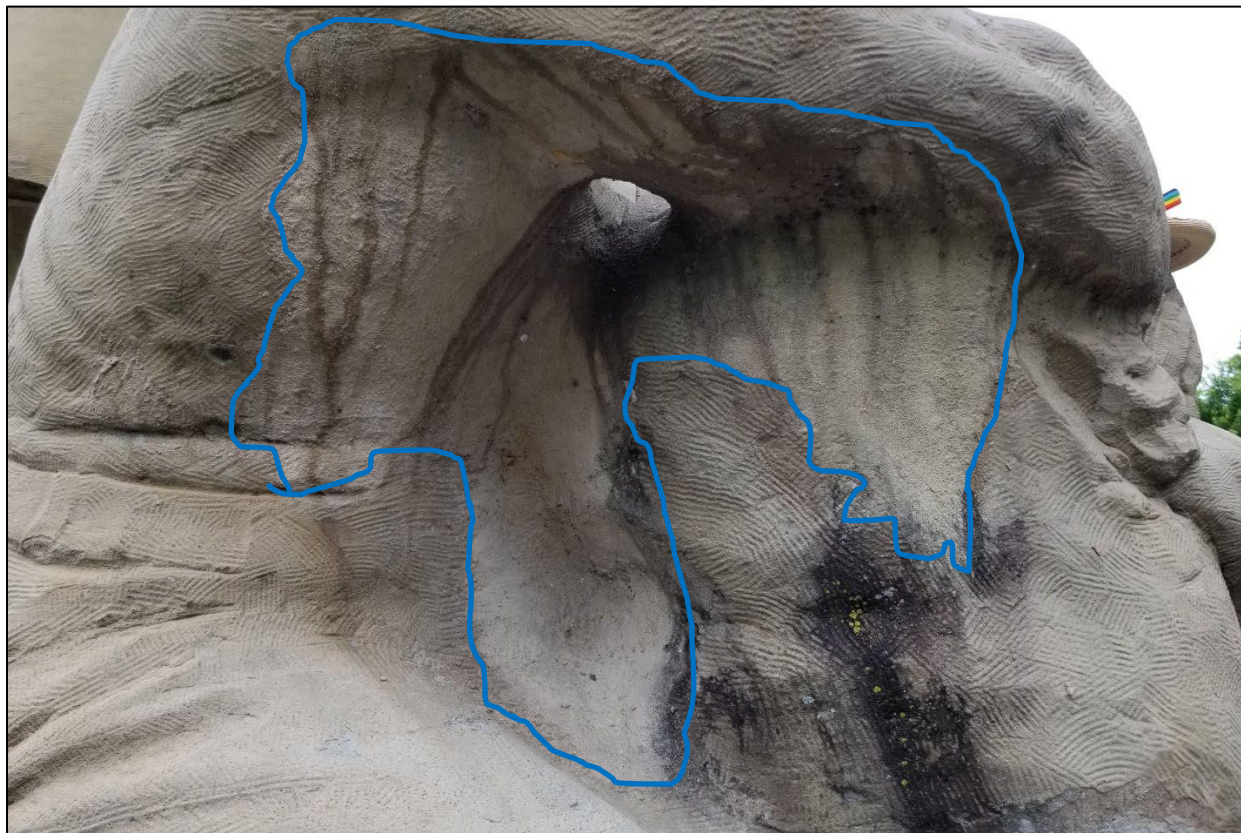
Photo 11: Detail of the north side of the sculpture showing the intersection between two of the figures in the boat. The patched area is roughly outlined in blue. The edges of the patches are indistinct because the patch has been smeared out onto the stone surface. The very dark discoloration at the lower right is biological growth—a “biofilm” including many different types of organisms.

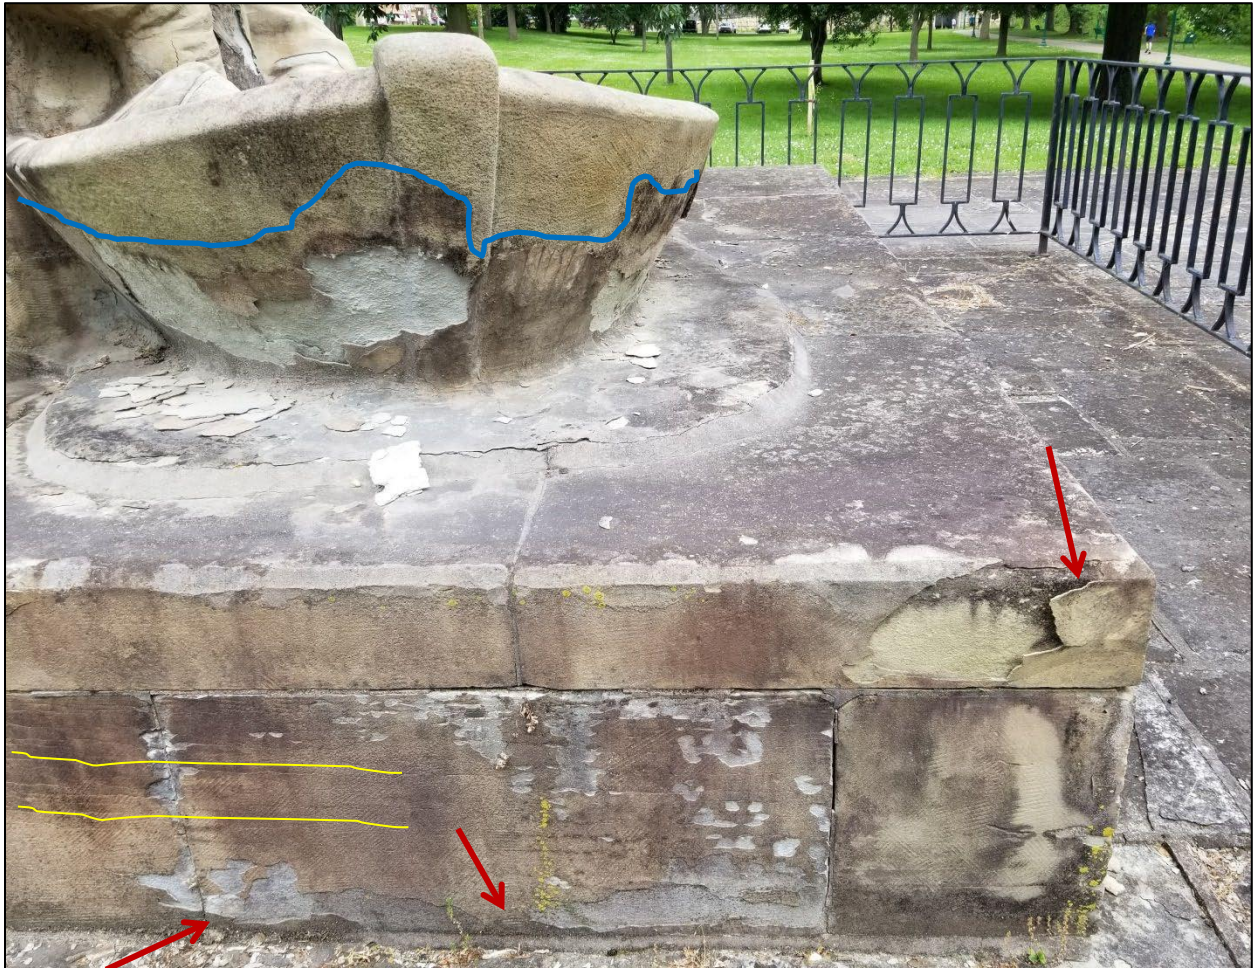
Photo 12: Detail of the north elevation of the sculpture towards the west end. Note the large area of failed patching at the side of the boat; other, adjacent patching is detached but has not yet fallen. This is the third type of patching noted, and seems to have been used extensively at the boat. It does not contain microspheres. The upper extent of patching is roughly outlined in blue. Note also the areas of peeling (defined under “Surface conditions”) at the ashlar base stone (red arrows), and the delamination along the bedding in the bottom course of the base (parallel to the yellow lines, visible as faint horizontal lines).

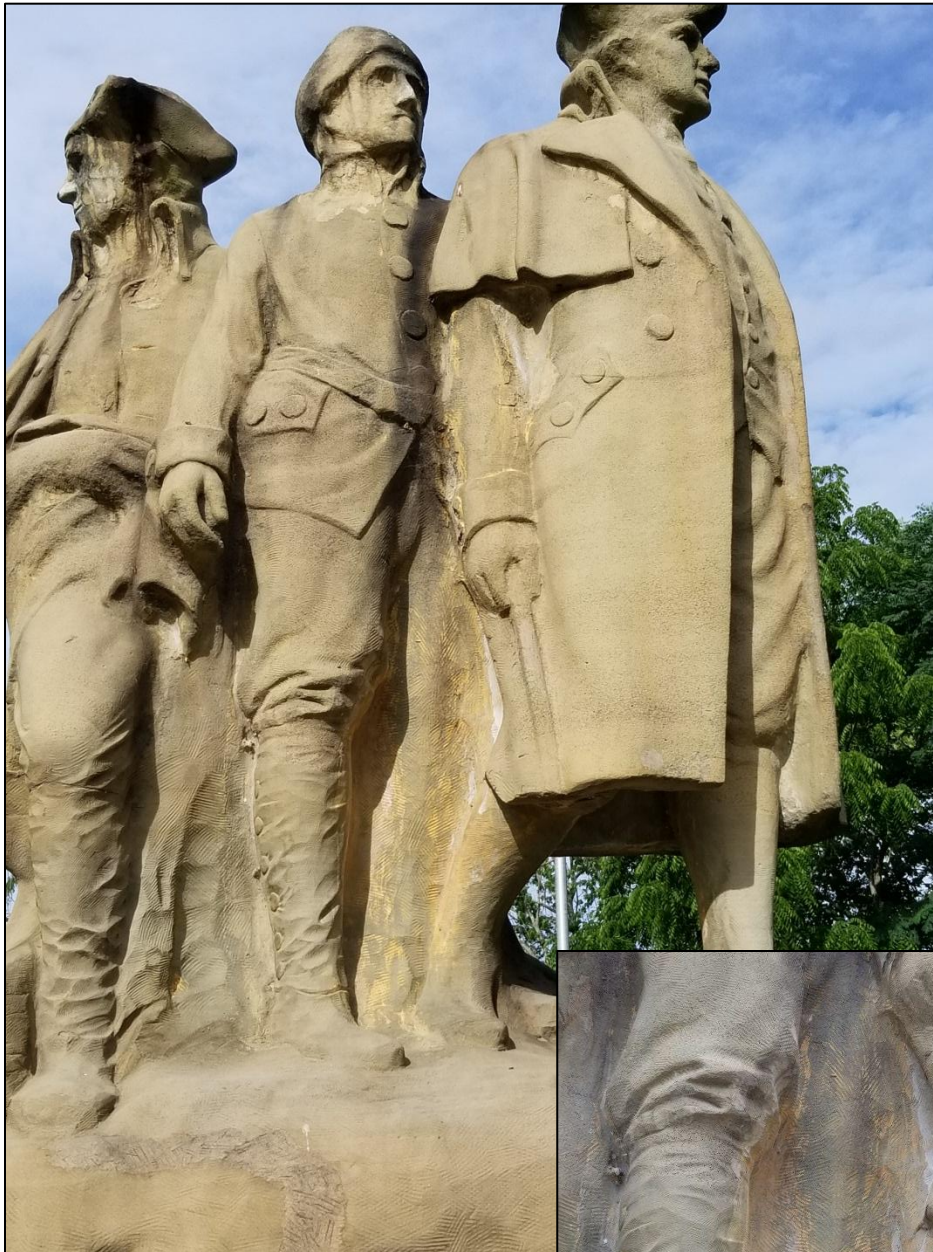
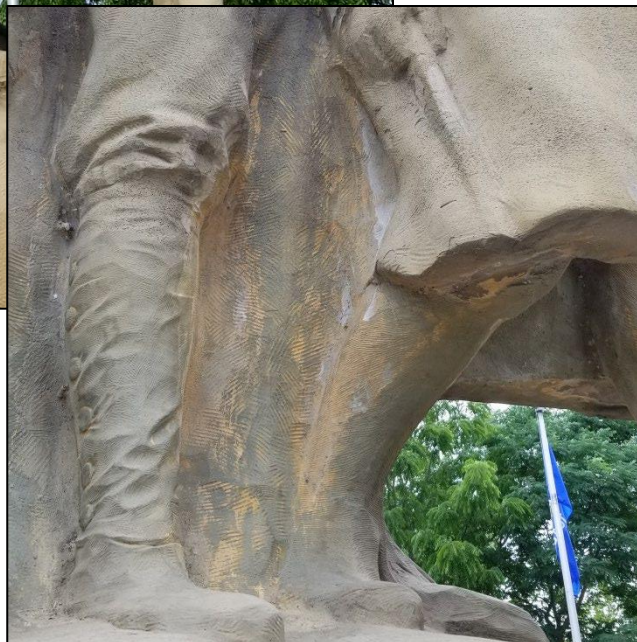
Photo 13: Details of the east elevation showing the orange material at the recesses and underside.

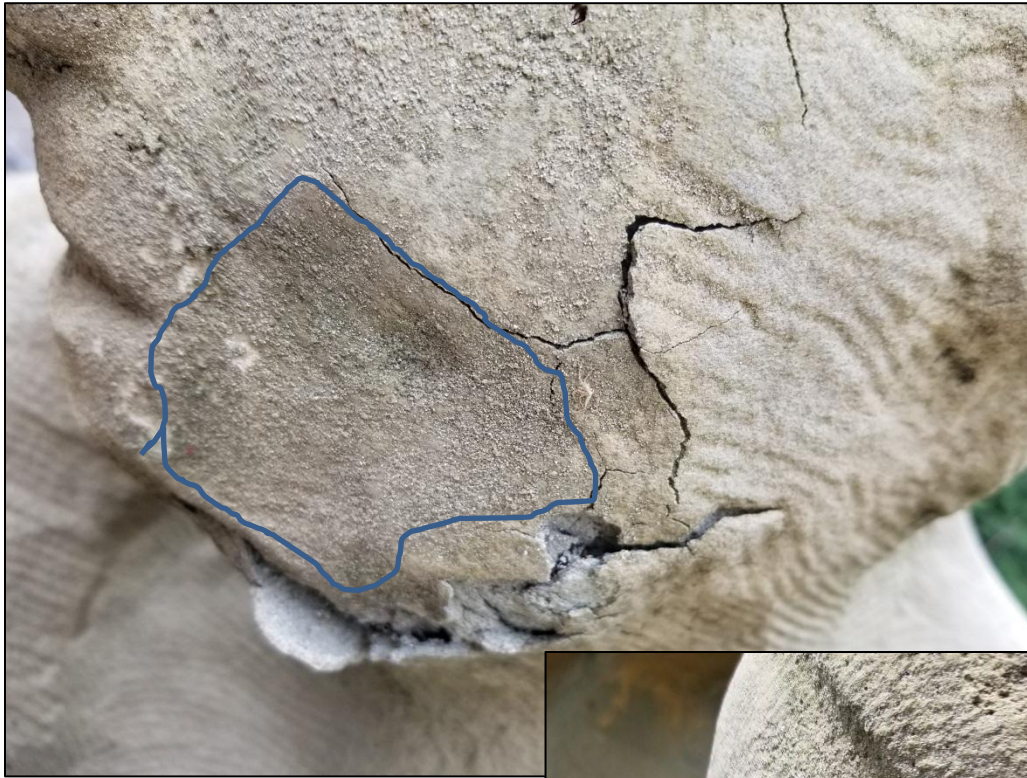
Photo 19, above: Detail of the side of the face shown in Photos 16-18 showing cracking and peeling in the vicinity of the coating and a larger patch at the jaw, roughly outlined in blue.

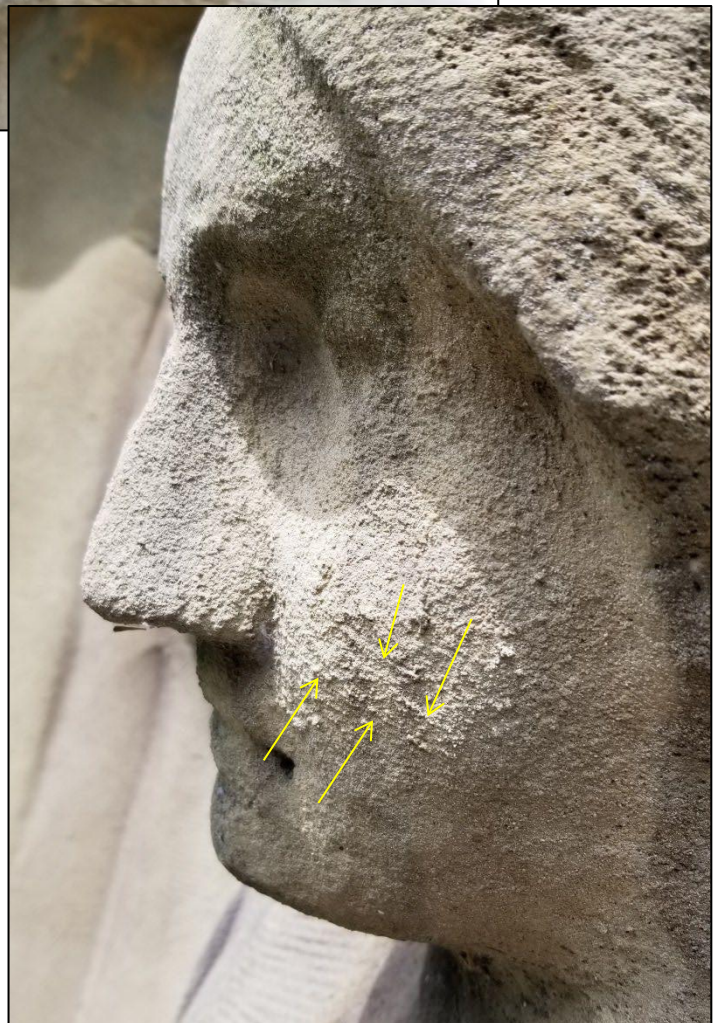
Photo 20, right: Detail of the southwest side of the female figure's face showing a similar coating application. Brushstrokes seem to be visible in the coating (yellow arrows).

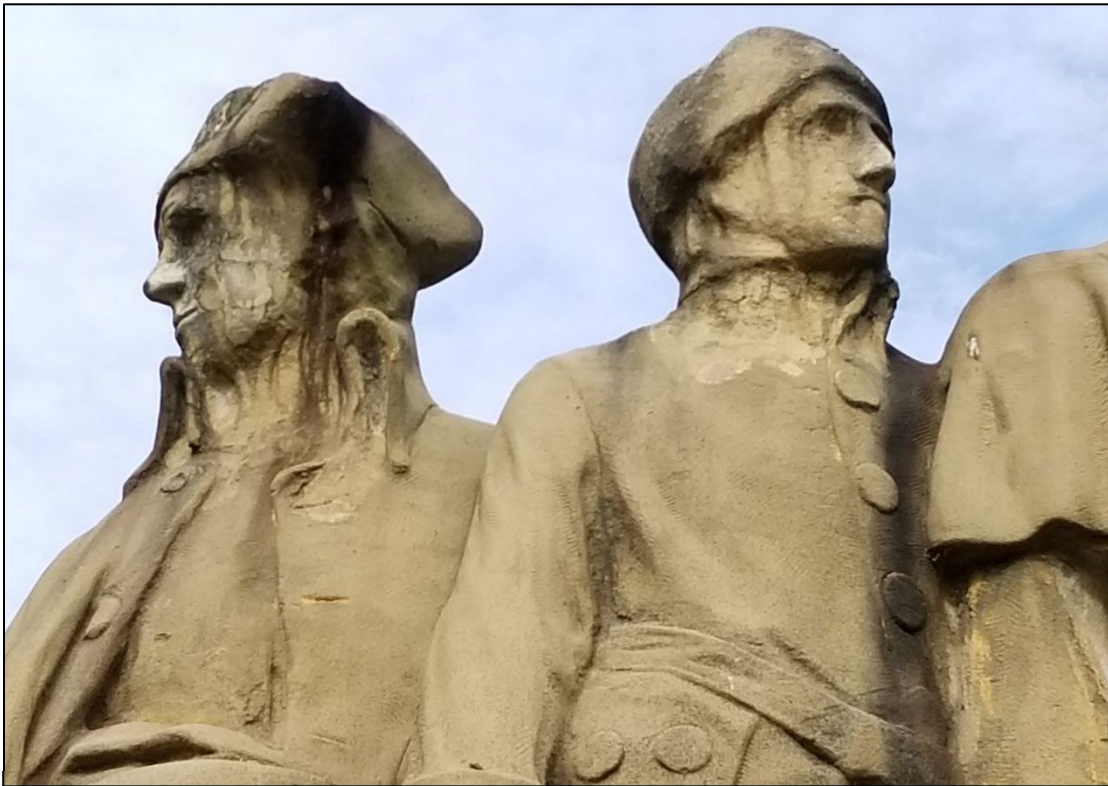
Photo 21: Detail of the heads of the center and south figures, which show obvious signs of intervention. Note the missing collar at the neck of the center figure, and the orange build-up on the jacket.

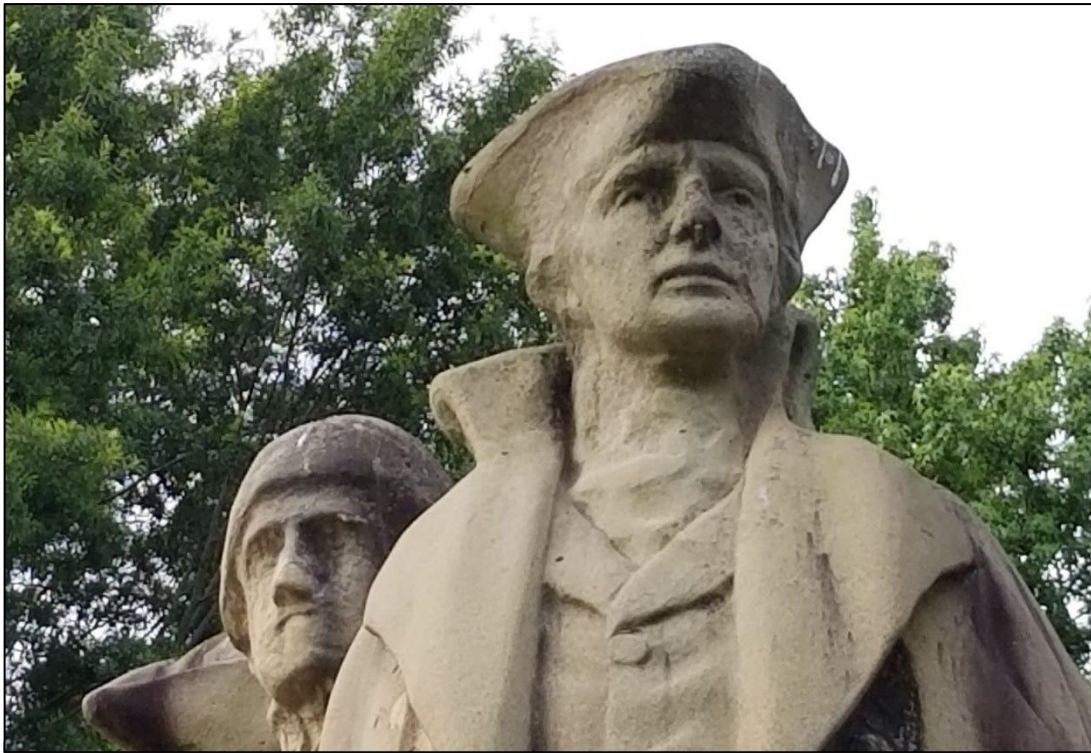
Photo 22: Detail of the heads of the center and north figures, which show the difference in detail. Note particularly the character of the eyes and mouth on the figure in the foreground.

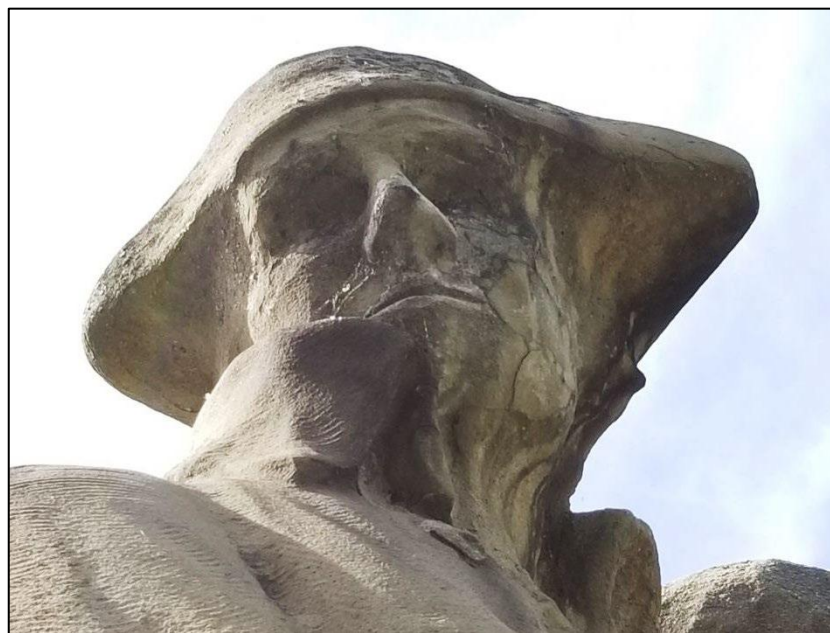
Photo 23: Detail of the head of the south figure showing the extent of repair. Each crack is associated with a patch.

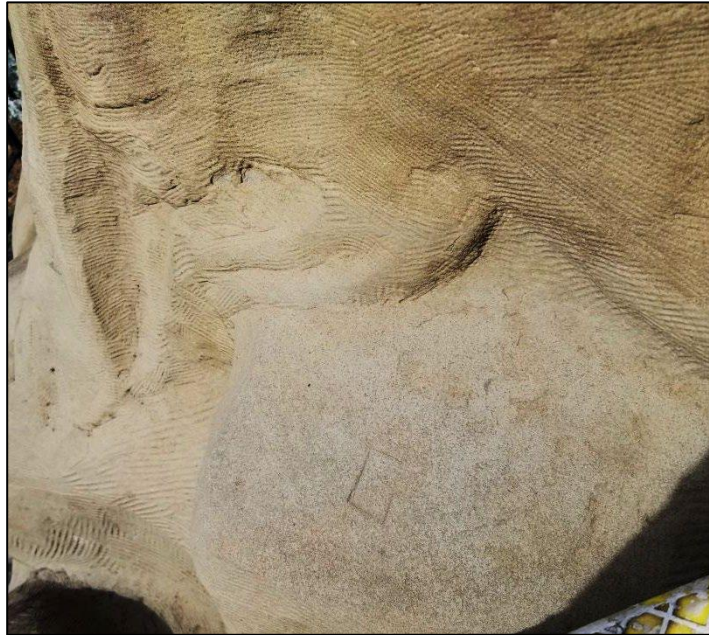
Hairline cracking: short, superficial cracks of limited extent; sometimes these cracks radiate from a point, but not always. In the image, multiple cracks (yellow arrows) extend from a central point (red arrow; brightness and contrast have been adjusted in the image to enhance the detail).

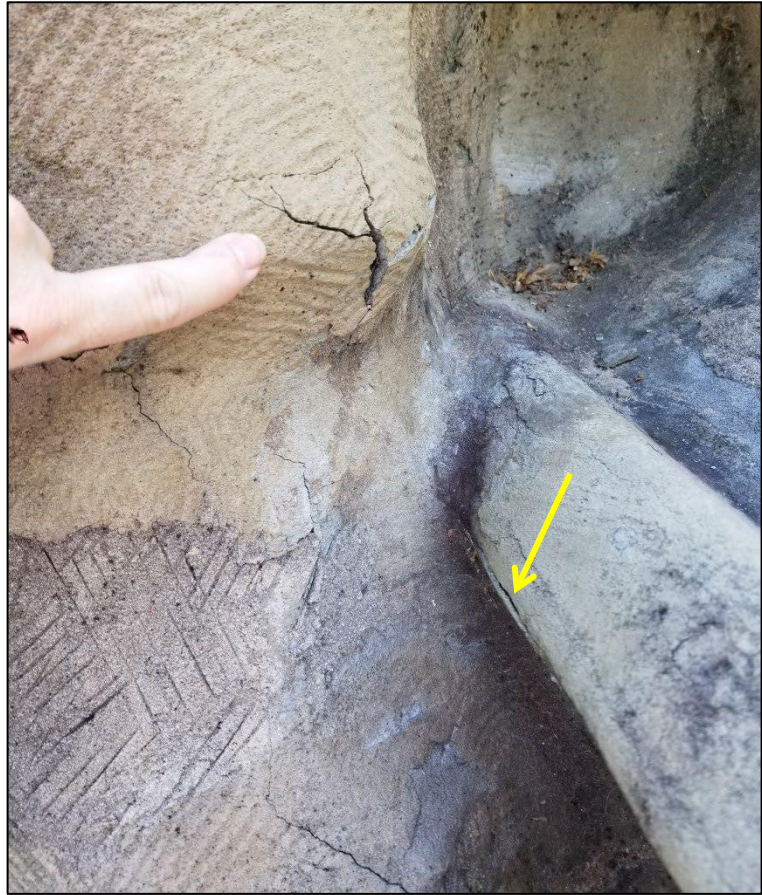
Peeling: loss of the surface layer of stone, and the natural next step after blistering. The term “spalling” may be used where the thickness of the loss is somewhat greater. The surface area of the underlying stone is always greater than what has come away, increasing the rate of deterioration. See Photo 12 which shows the location of this detail image. Once the surface peels off, the stone beneath begins to erode.

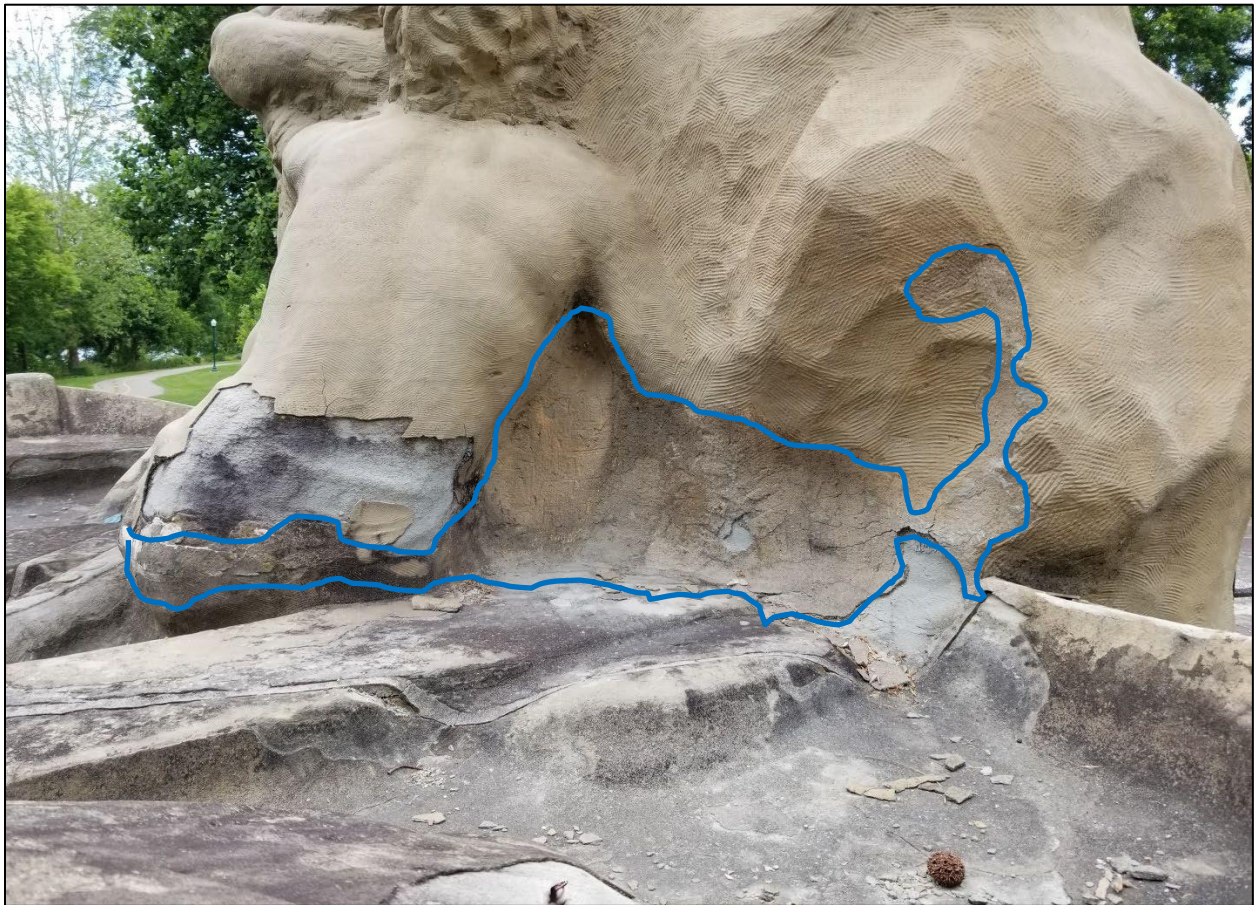
Photo 24: Detail of the intersection of the rear sculpture group with the boat showing the cracking, blistering, and peeling of the surface and previous patch repairs (outlined roughly in blue) indicating this is has been an ongoing problem. The thickness of the stone surface loss at the figure is approximately $\frac{1}{4}$ inch. The previously applied patch repairs are also peeling away because the material was applied too thinly and not mechanically keyed.

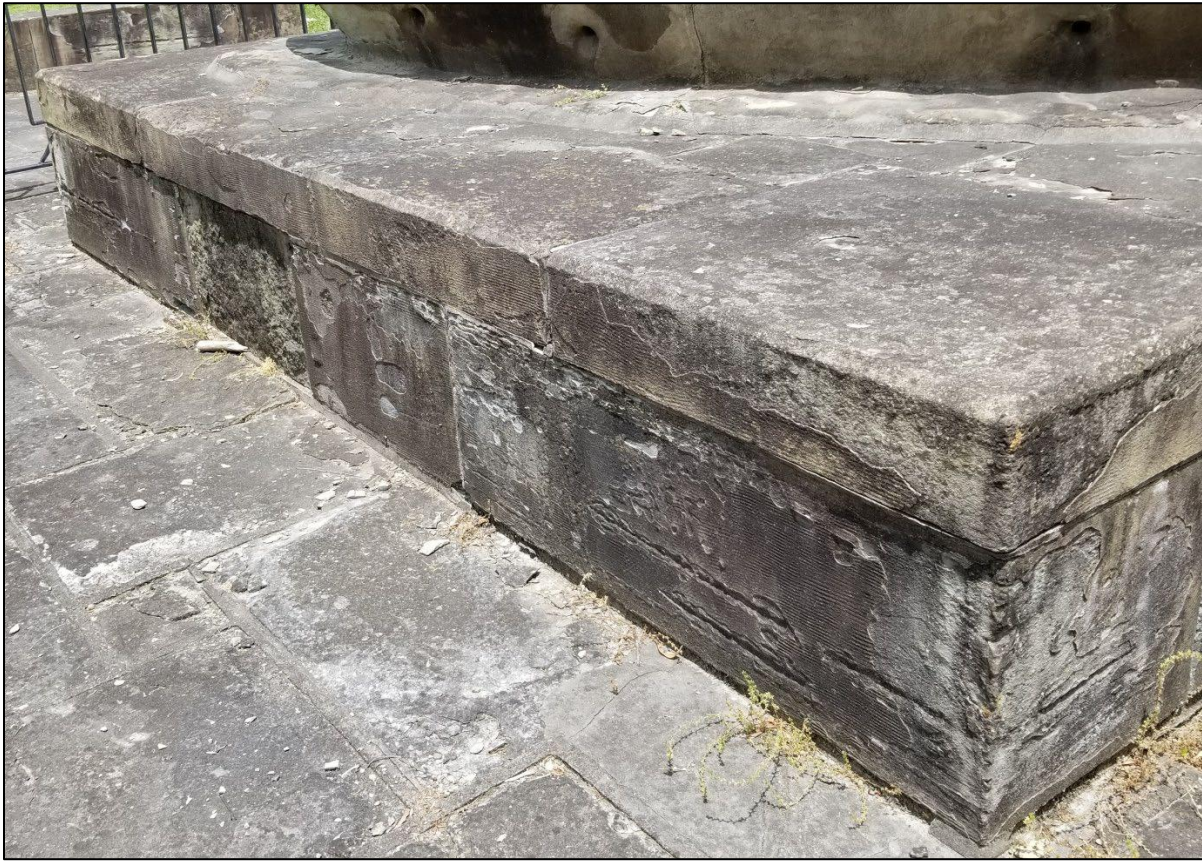
Photo 25: Detail of the west elevation of the base in raking light showing the extent of the surface deterioration.

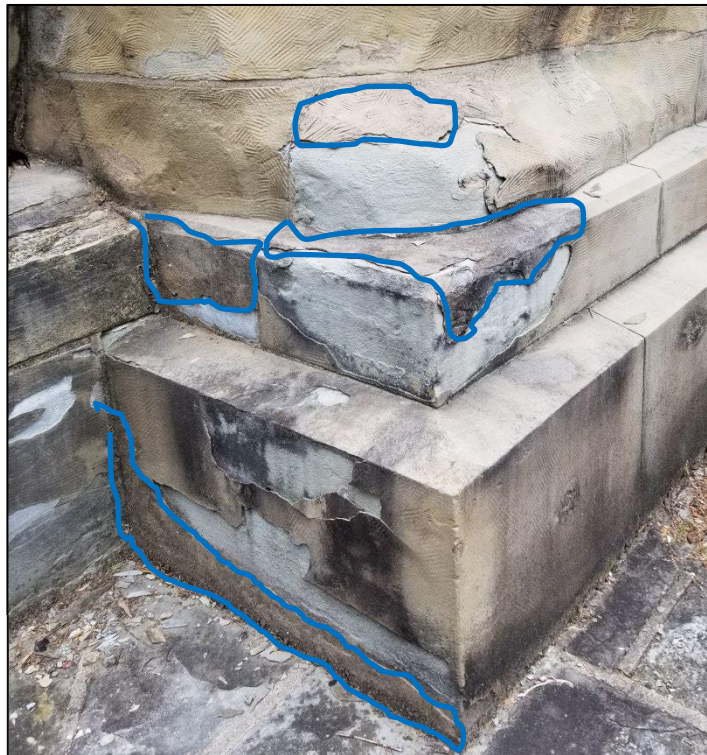
Photo 26: Detail of the southeast corner of the sculpture showing deterioration related to patching. The patches are roughly outlined in blue.

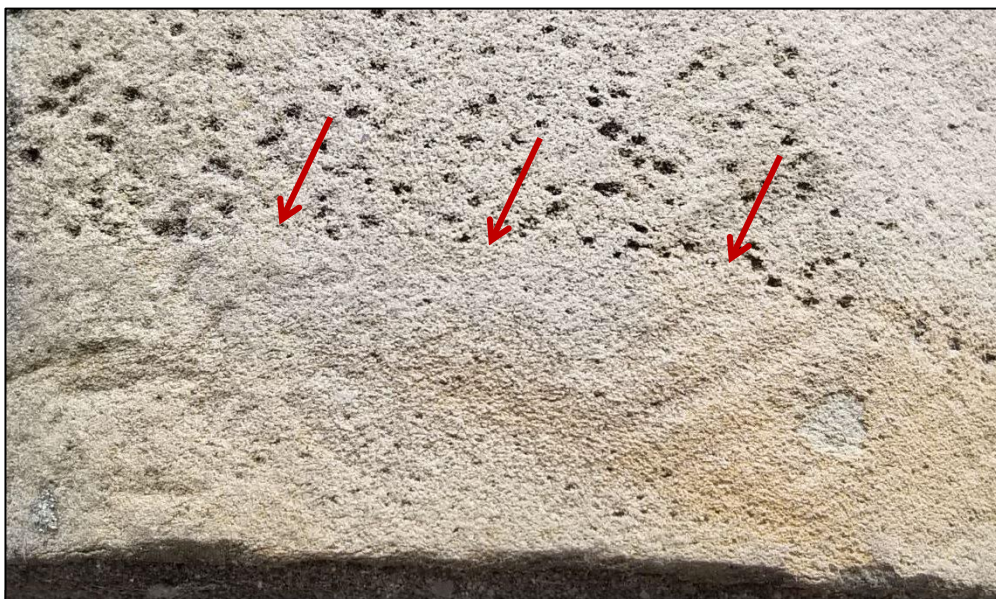
Photo 27: Bedding in the sculpture sandstone. West side, along bottom of coat of north figure.

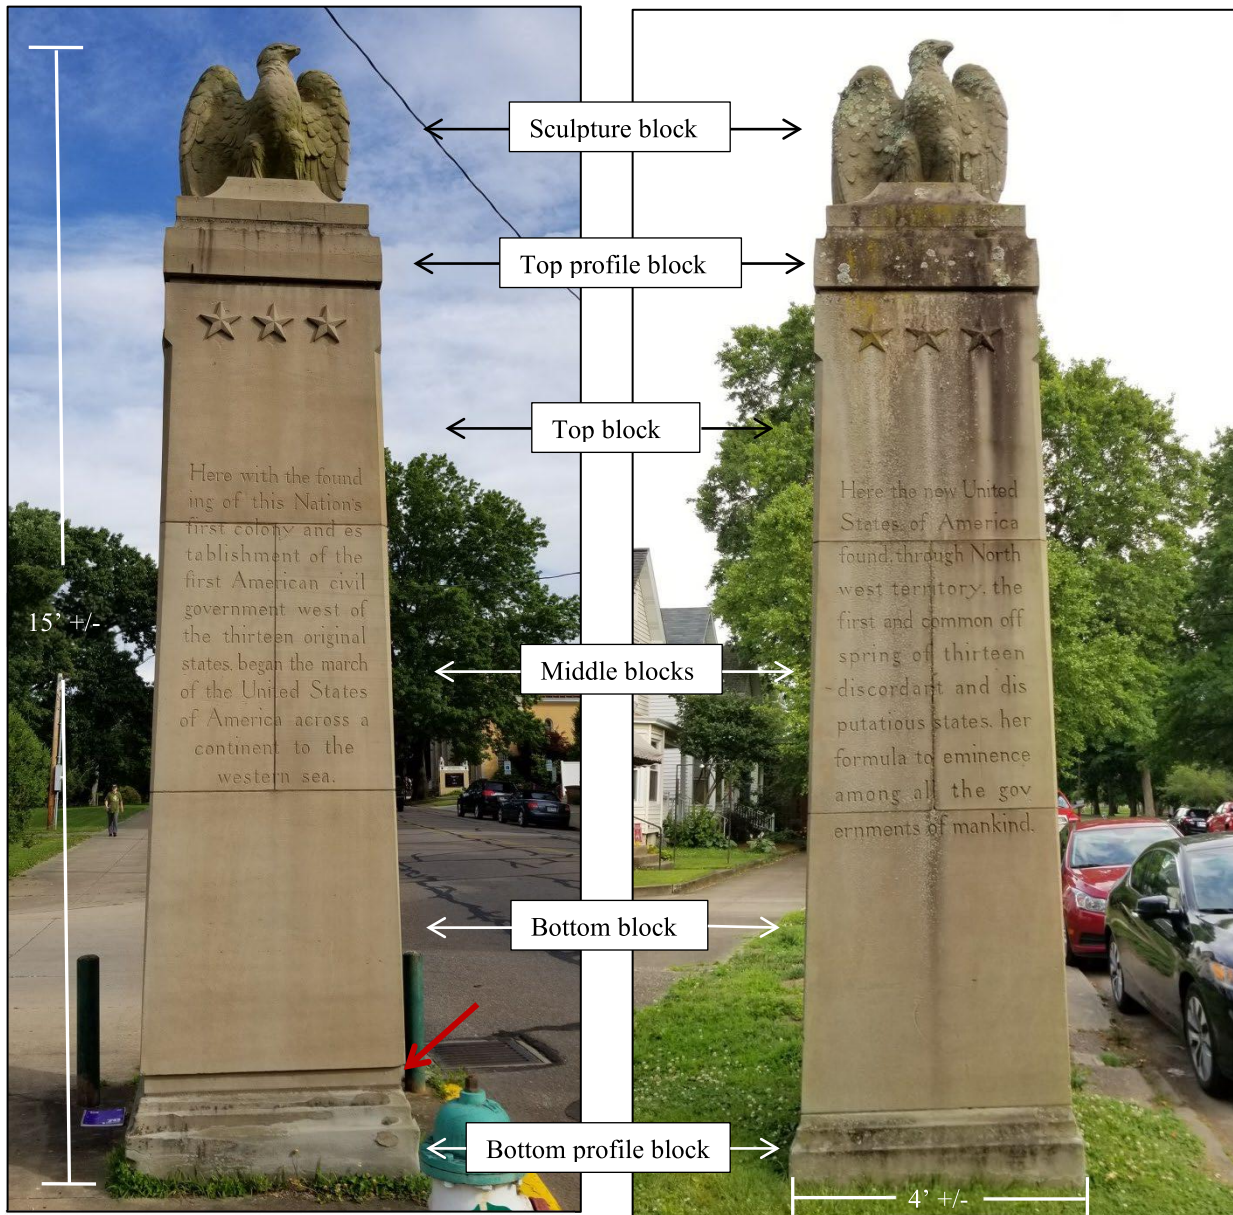
Photo 28: Southwest pylon, south elevation, corner of Front and Putnam streets. Note the slight recess at the bottom of the bottom-center block (red arrow).

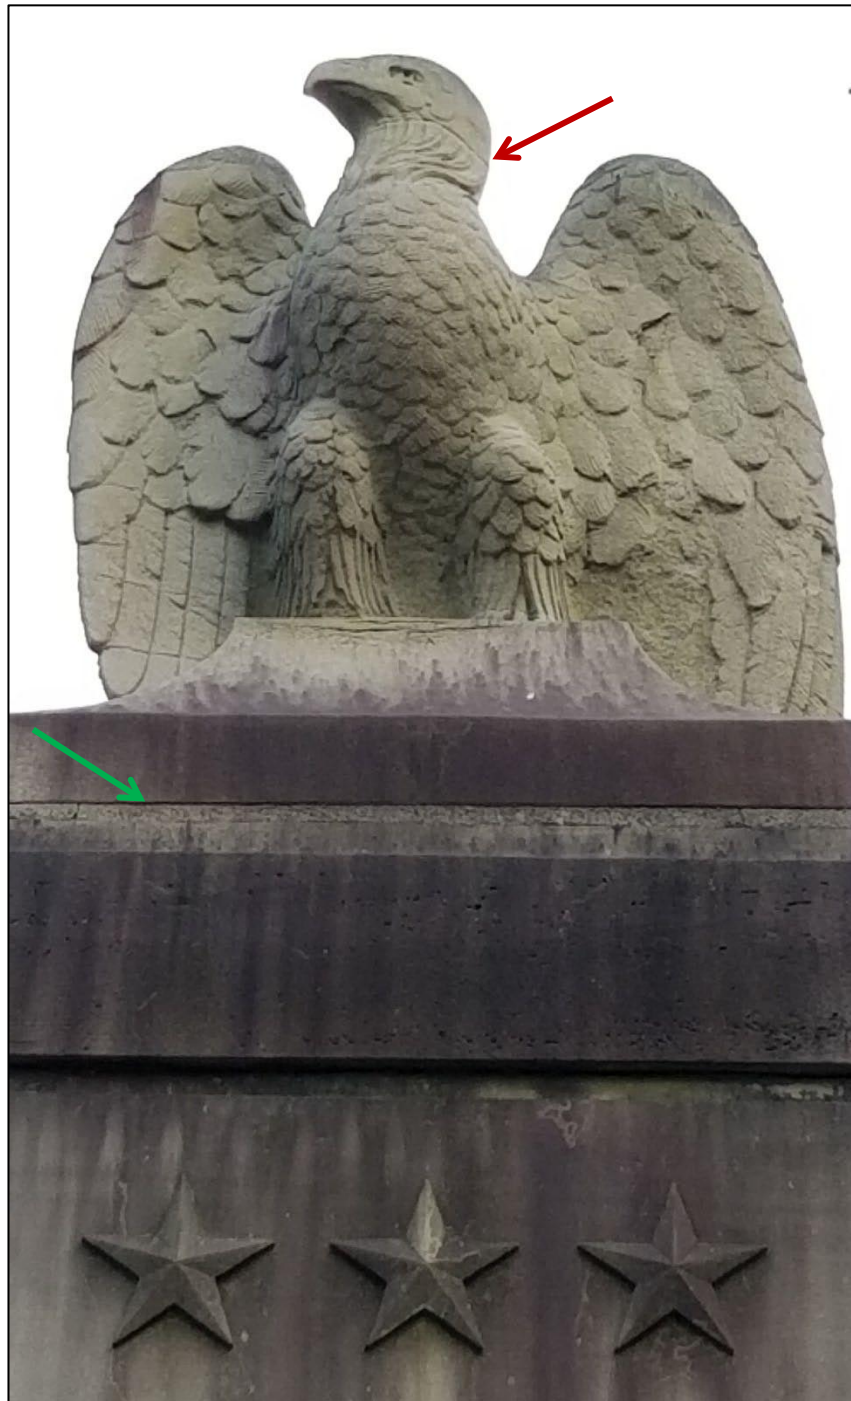
Photo 30: Detail of the eagle at the northwest pylon, west elevation. Note the joint at just below the beak showing the head is a separate piece of stone (red arrow). The stone deterioration at the bottom of the right wing and between the legs is typical; similar deterioration is often seen at the back of the eagle on the wings. The streaky purple material is biological growth. Note the wide joint between the sculpture block and the top profile block (green arrow).

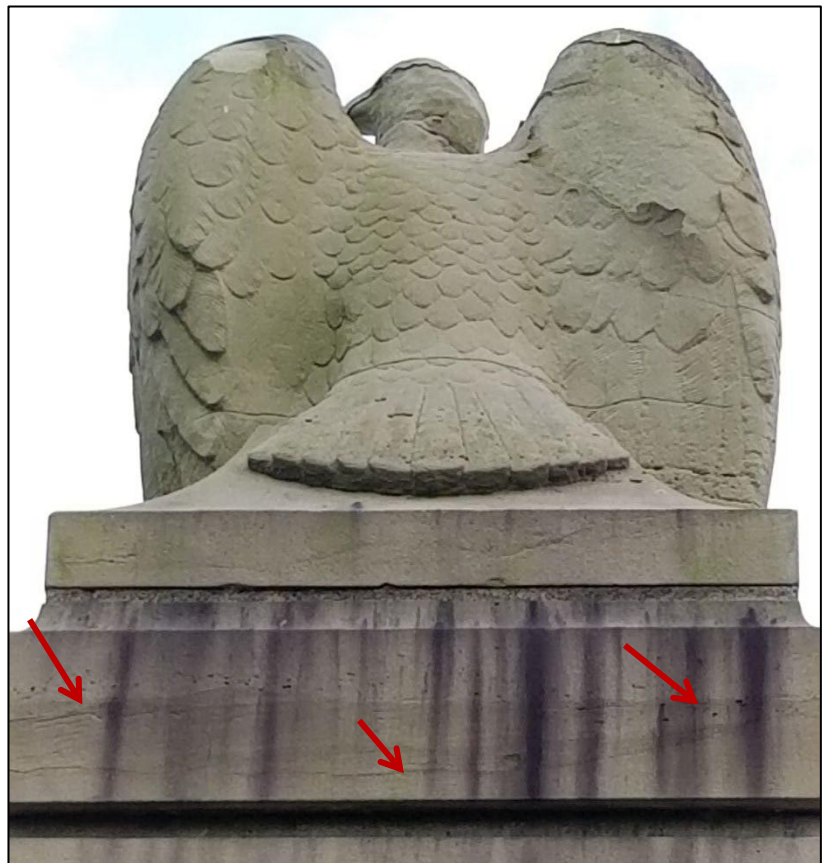
Photo 32: Detail of the rear of the eagle at the southwest pylon, north elevation. Note the peeling stone at the head and tops of the wings. The green is biological growth, as are the streaks of purple. The delamination of the top profile block is clearly visible (red arrows).

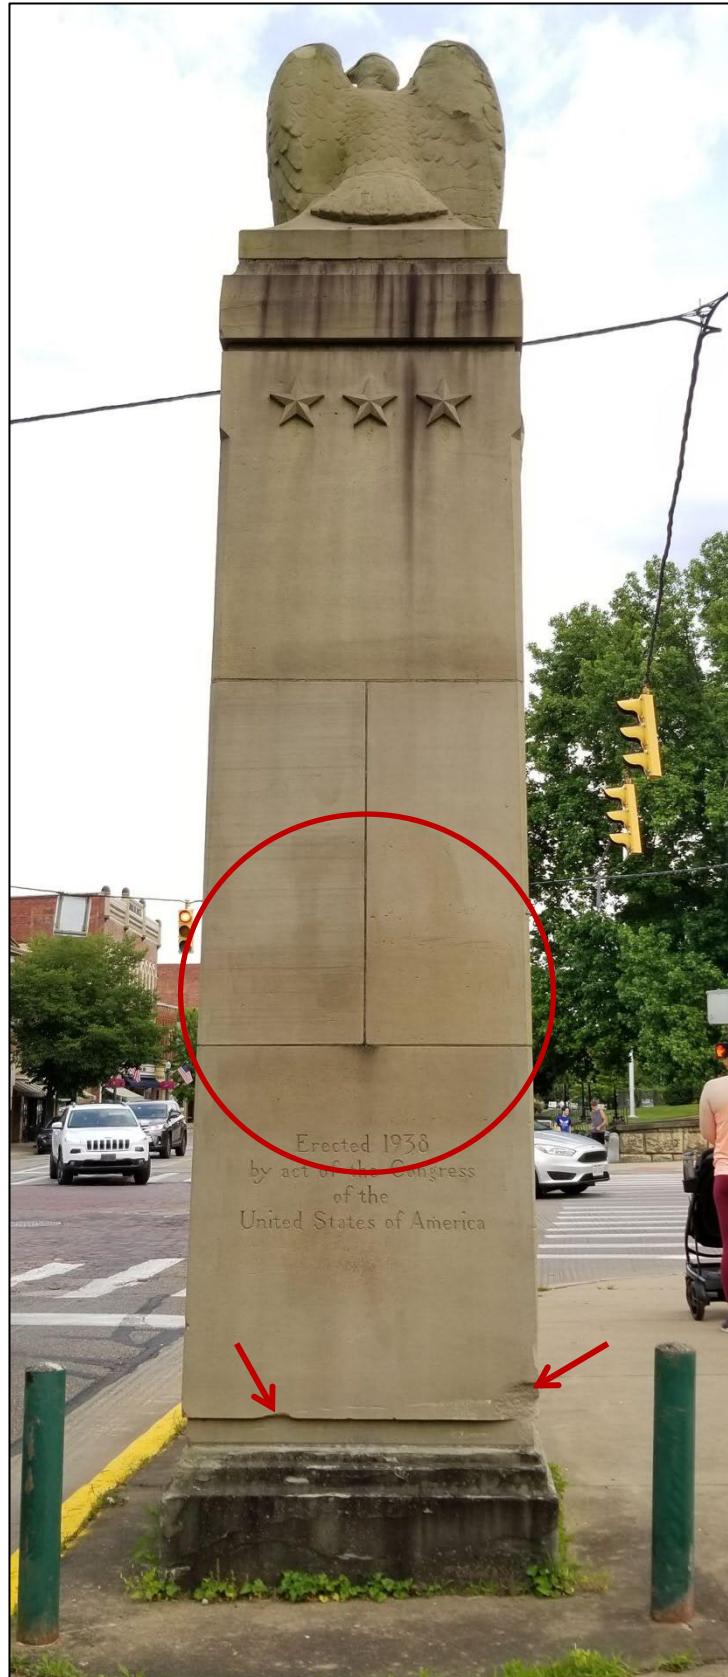
Photo 33: Overall view of the north elevation of the southwest pylon. The green on the eagle is biological growth, as are the streaks of purple—this is the most pronounced biological soiling on this pylon with the exception of the base. This view shows evidence of a previous graffiti removal effort (circled), and also impact damage near the base (arrows). The bollards were likely installed after the damage.

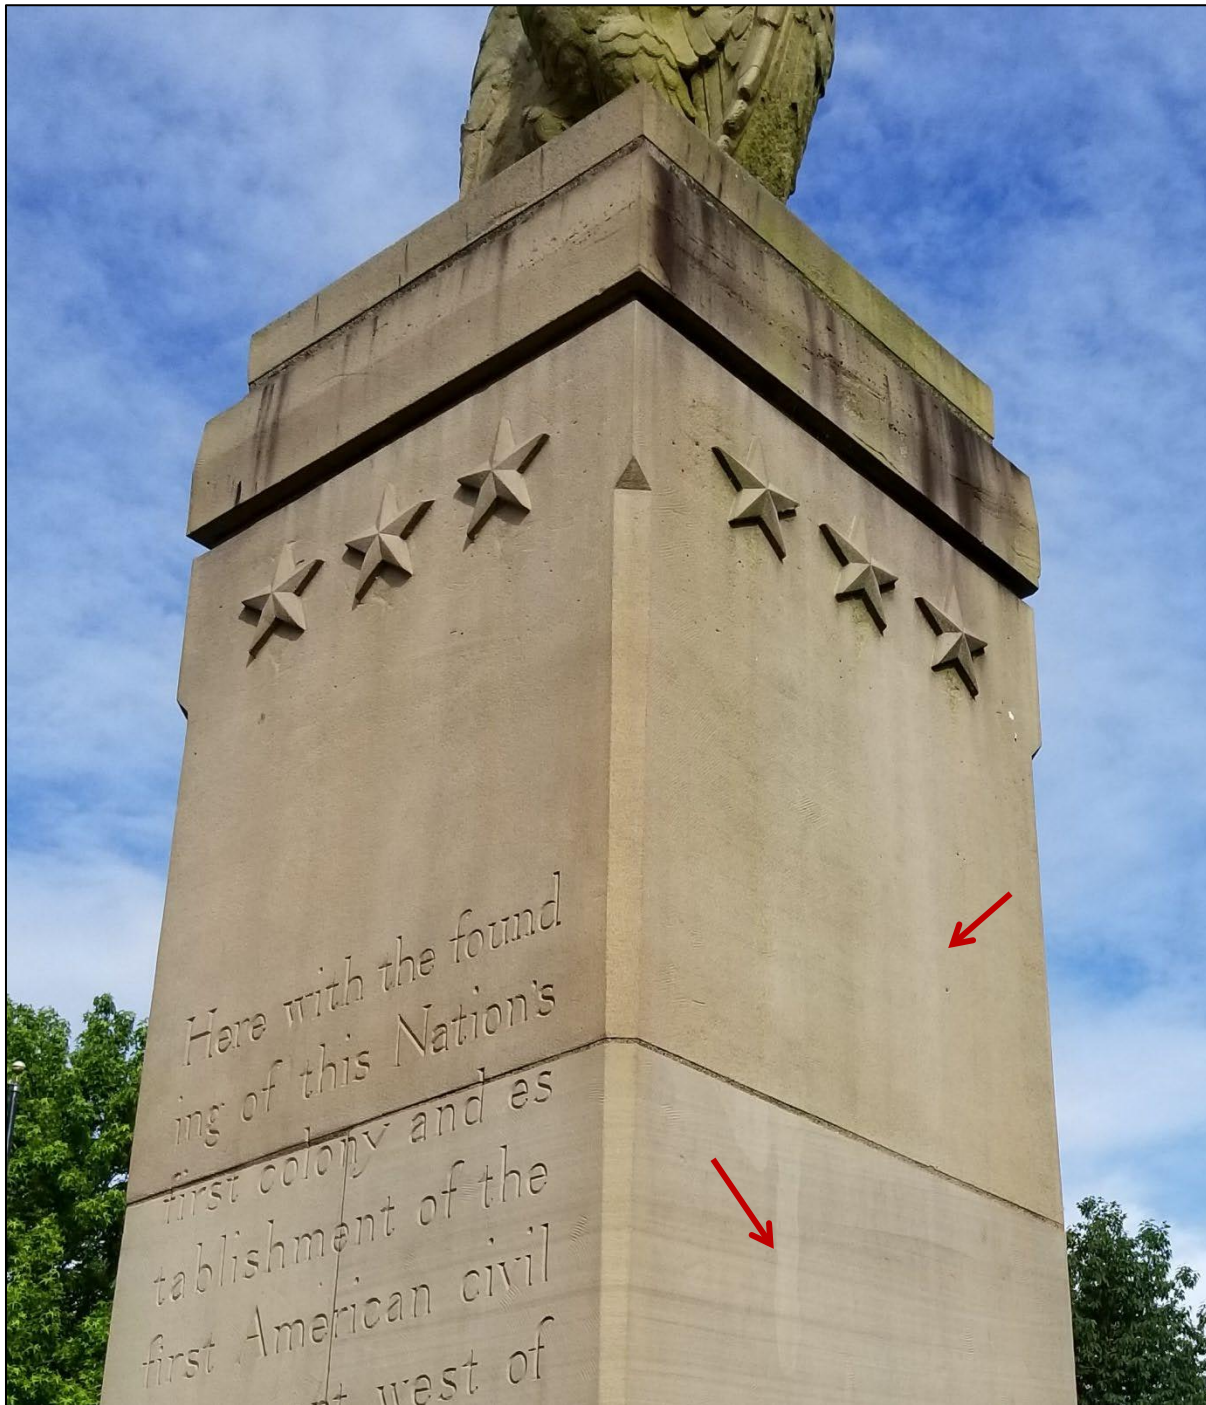
Photo 34: Detail of the southeast corner of the southwest pylon. The white streaks on the east elevation are distinct evidence of a previous cleaning, possibly with an acidic material. Many products sold for cleaning sandstone and granite are acidic, and require careful dilution and application as they can easily cause this kind of discoloration.

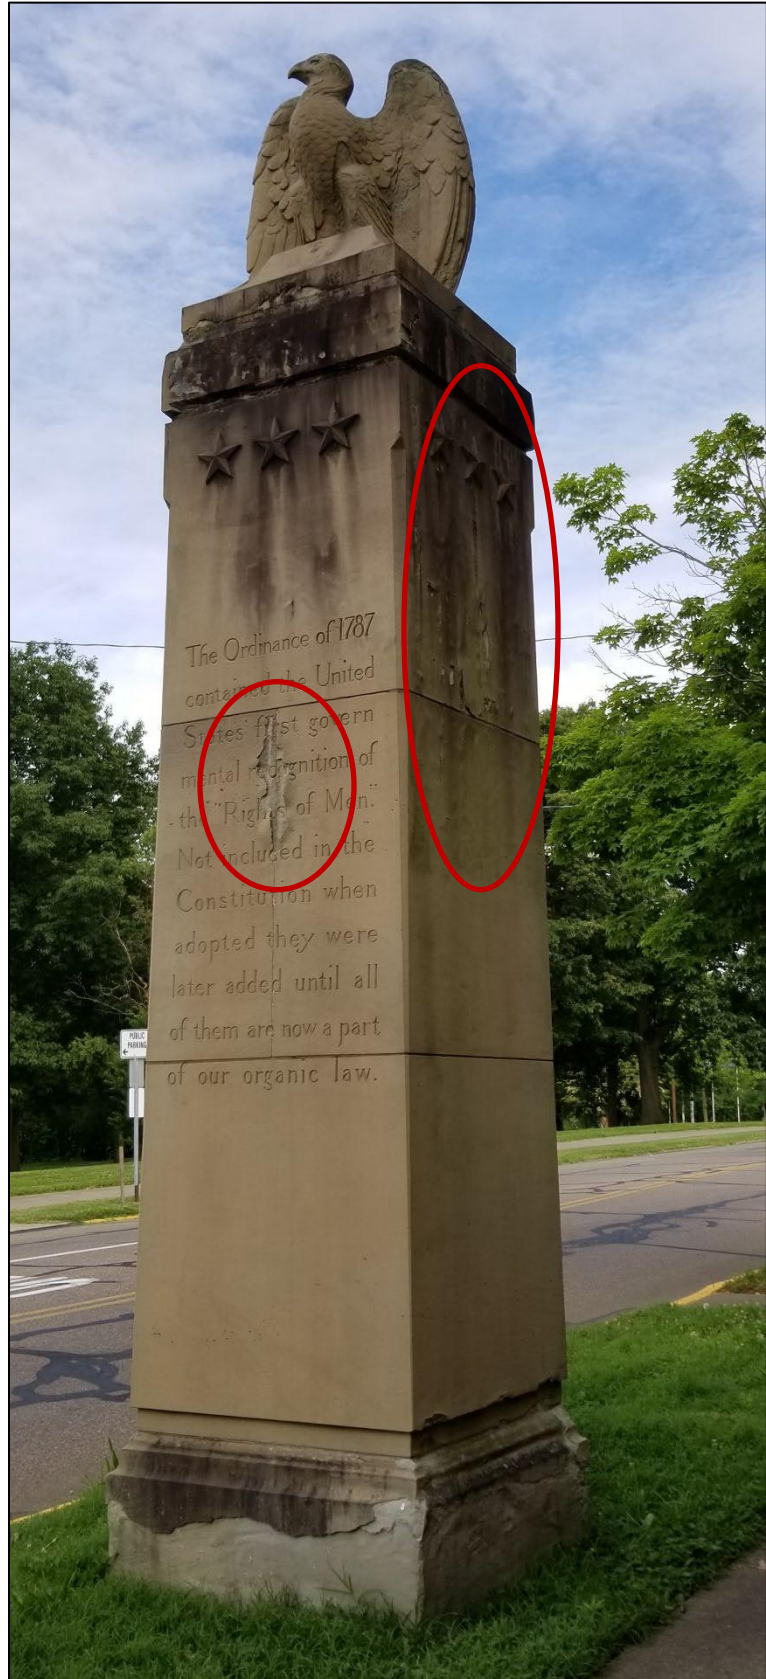
Photo 35: View of the southeast corner of the southeast pylon. There is readily visible blistering and peeling of the middle blocks at the south elevation, and of the top block at the east elevation (red circles). Similar deterioration at the profile block is harder to read in the image. Note also the peeling and erosion of the bottom profile block. The pronounced biological soiling is typical of all elevations of this pylon except the west.
