CONSERVATION ASSESSMENT

MEMORIAL TO THE START WESTWARD SCULPTURE AND PYLONS MARIETTA, OHIO

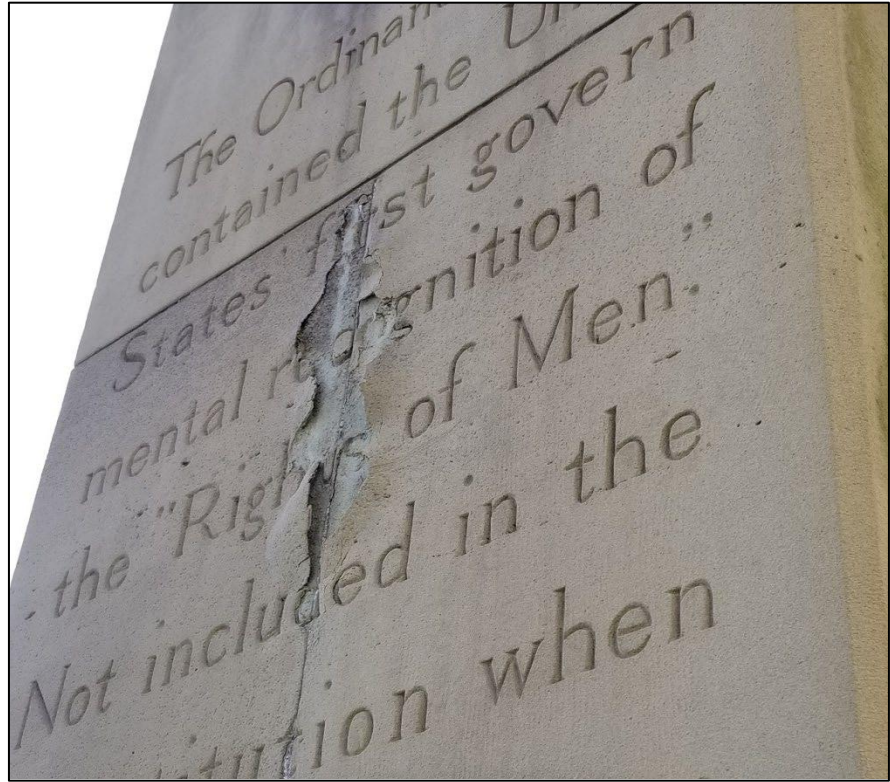
Photo 37: Detail of the east elevation of the southeast pylon. Note the blistering and peeling and green biological growth. There is also evidence of damage from power washing in the form of streaks with a line at the end (red rectangle).

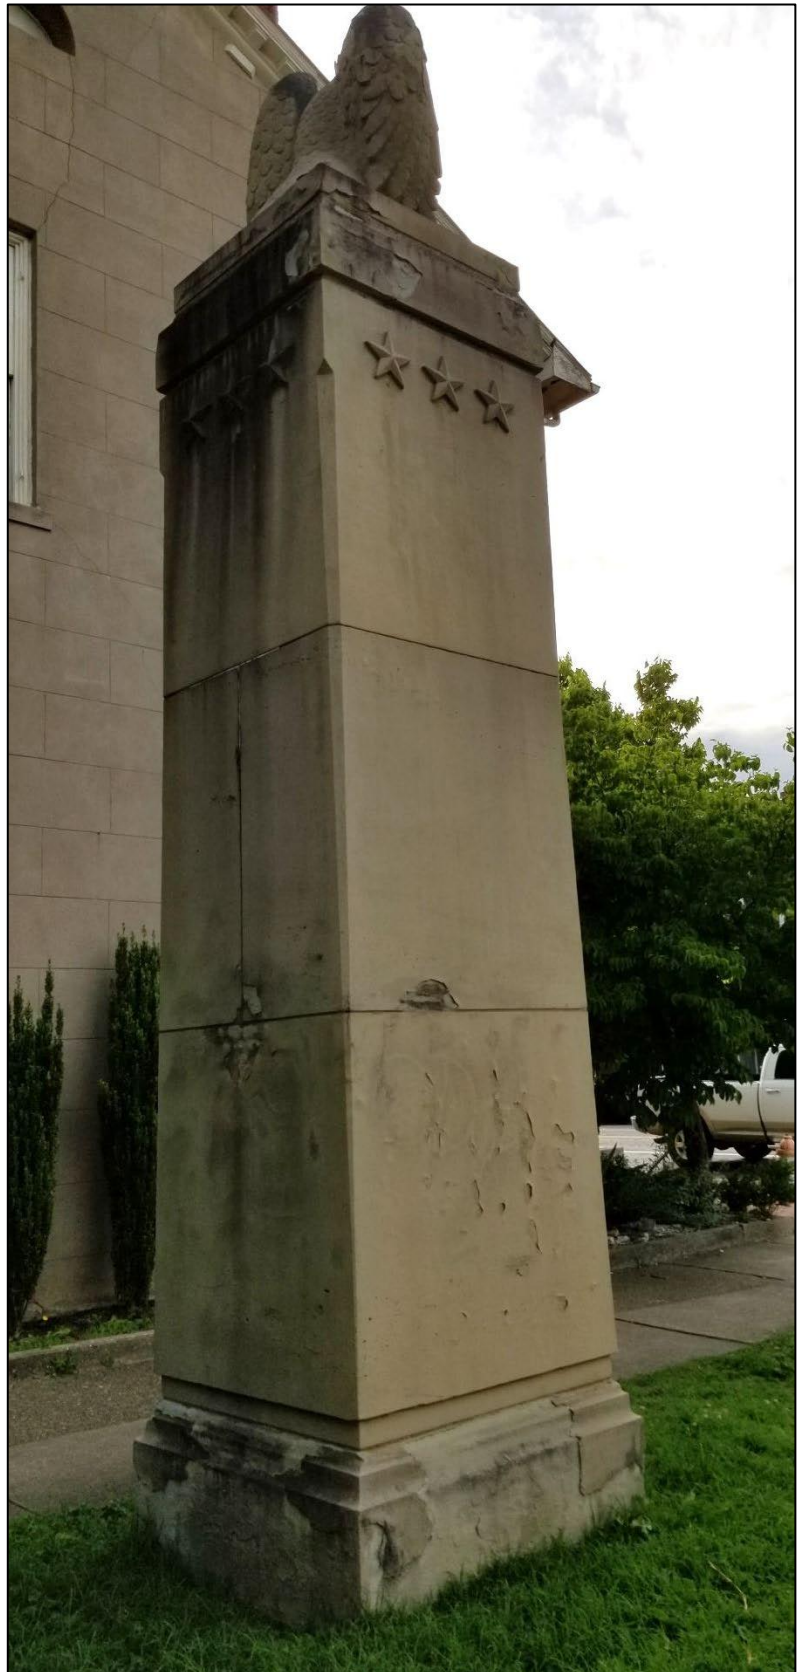
Photo 38: View of the northwest corner of the southeast pylon. The areas of blistering and peeling both seem to be associated at areas of previous graffiti removal. Note also the blistering and peeling at the top and bottom profile blocks.

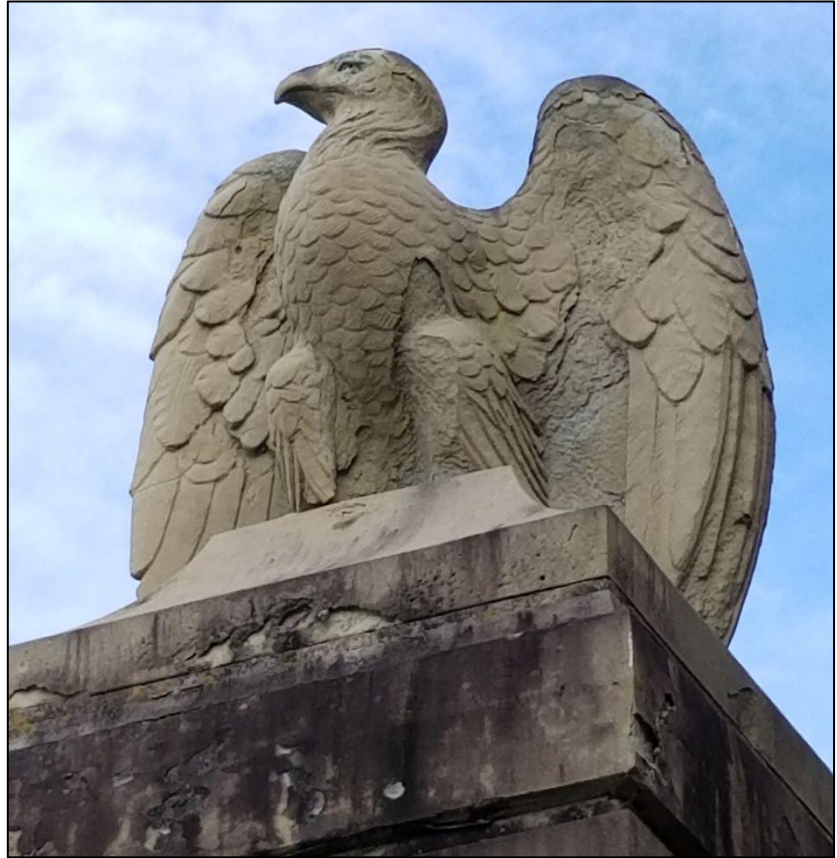
Photo 40: View of the back (north) side of the eagle sculpture on the southeast pylon. Note the deterioration on the top of the wing. Note also the biological growth, blistering, and peeling on the base of the sculpture block and the top profile block

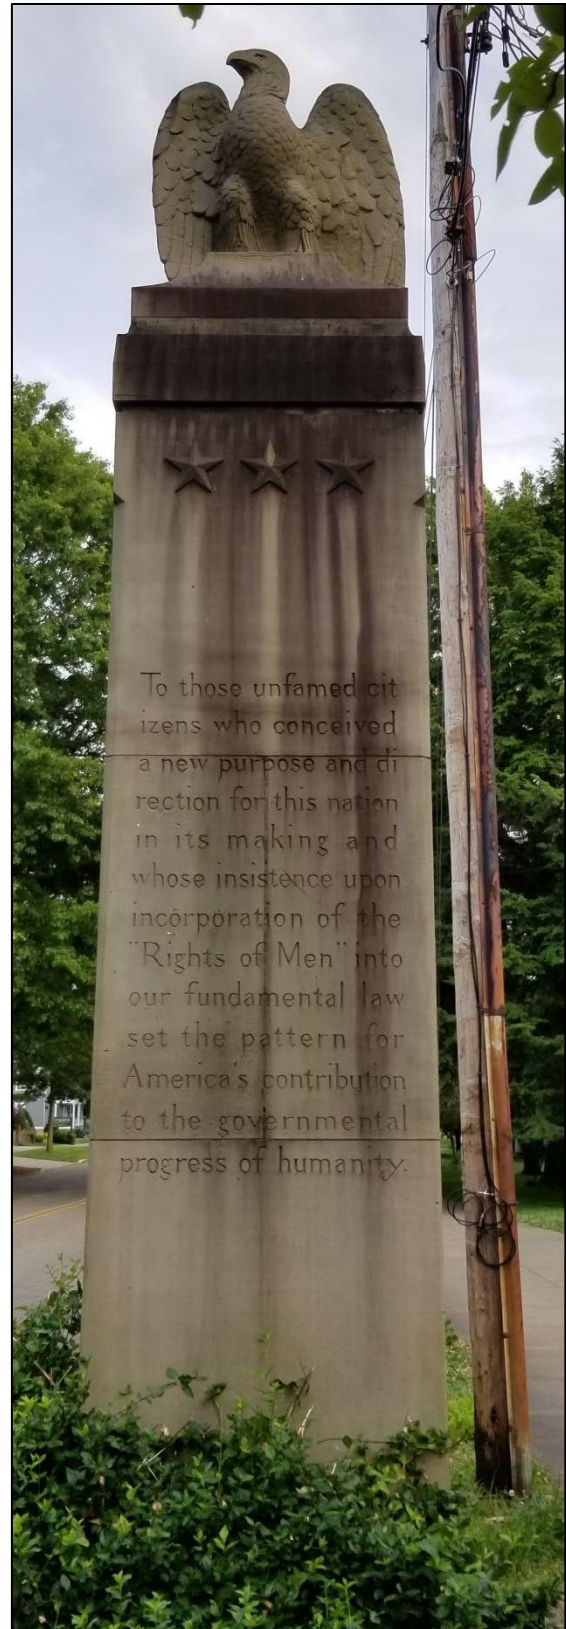
Photo 41: View of the north elevation of the northwest pylon. The plants completely cover the bottom profile block at this and the east elevation. Note the heavy biological growth which is most extensive at this elevation.

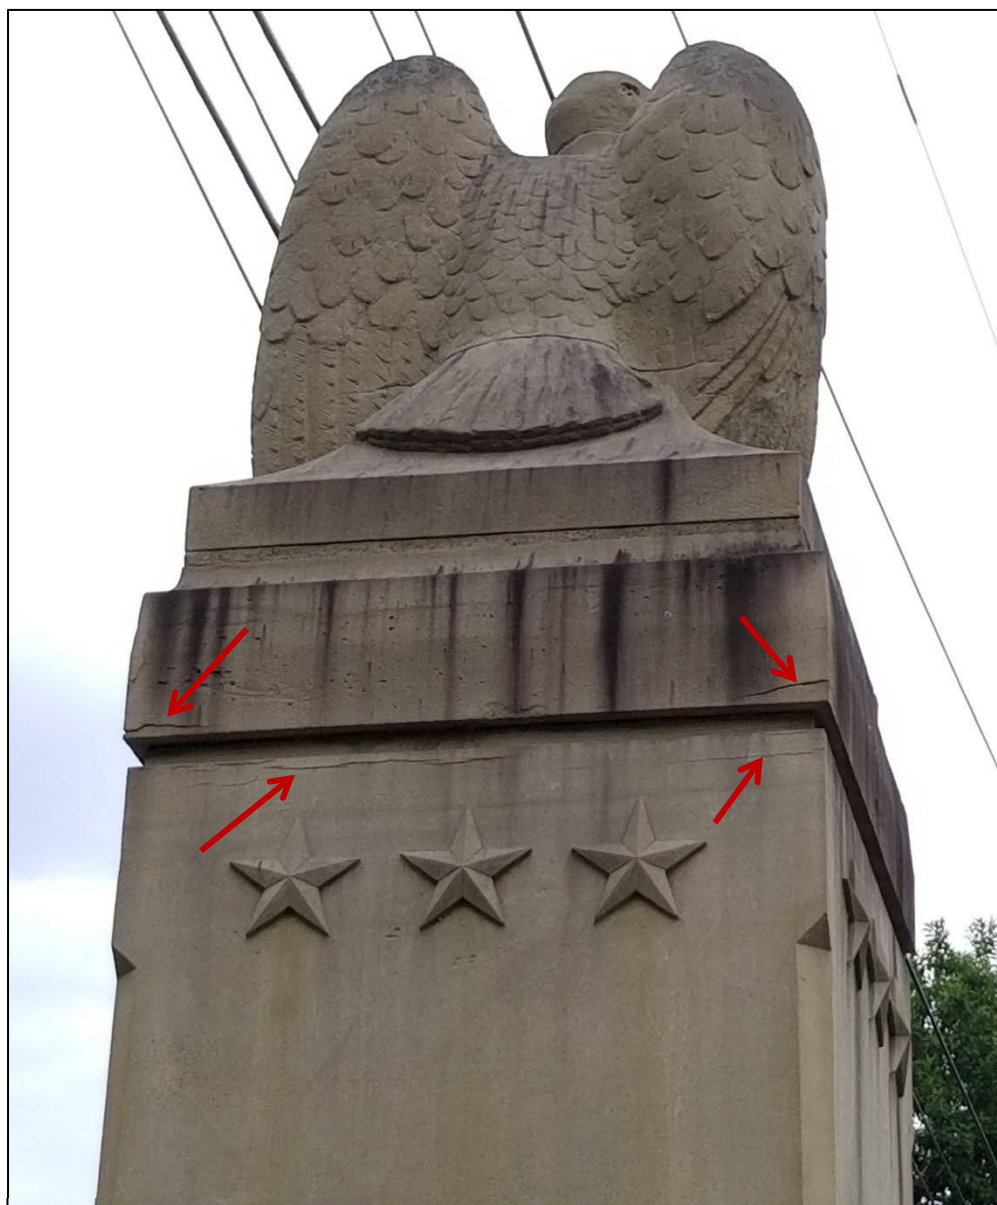
Photo 42: Detail of the south elevation of the northwest pylon showing the relatively minor stone deterioration at the sculpture. The degree of biological growth at the top profile block at this elevation is typical. Note also the delamination at the bottom of the top profile block and the top of the upper column block (arrows).

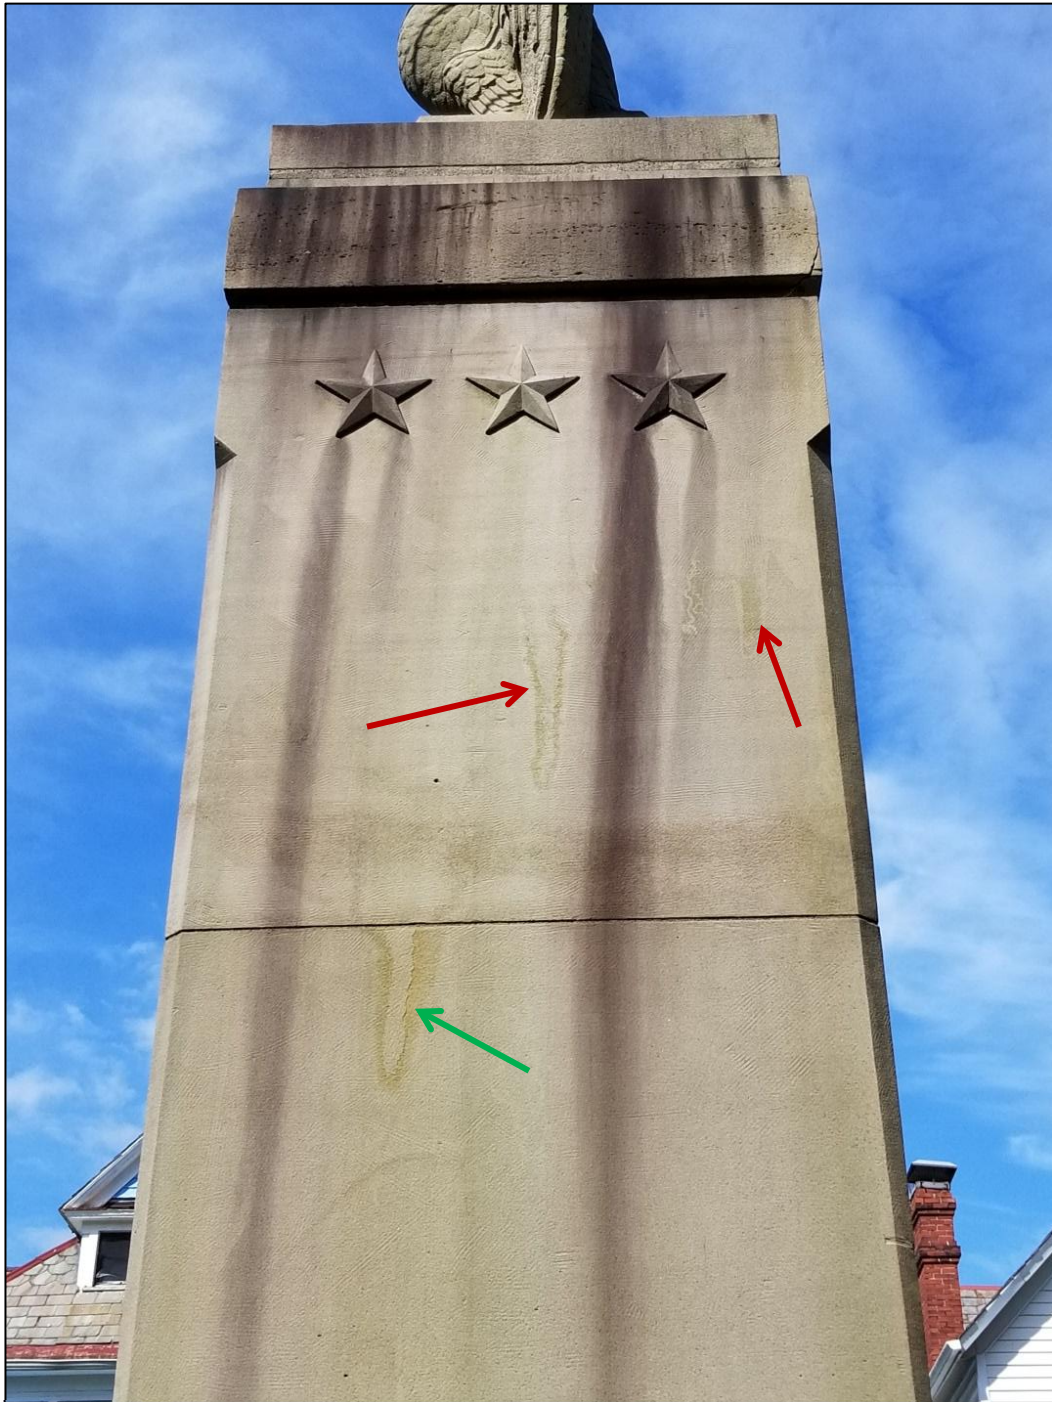
Photo 43: Detail of the west elevation of the northwest pylon showing streaking from a previous treatment (red arrows). At the green arrow, there is also stone erosion. The purple streaks are biological growth.

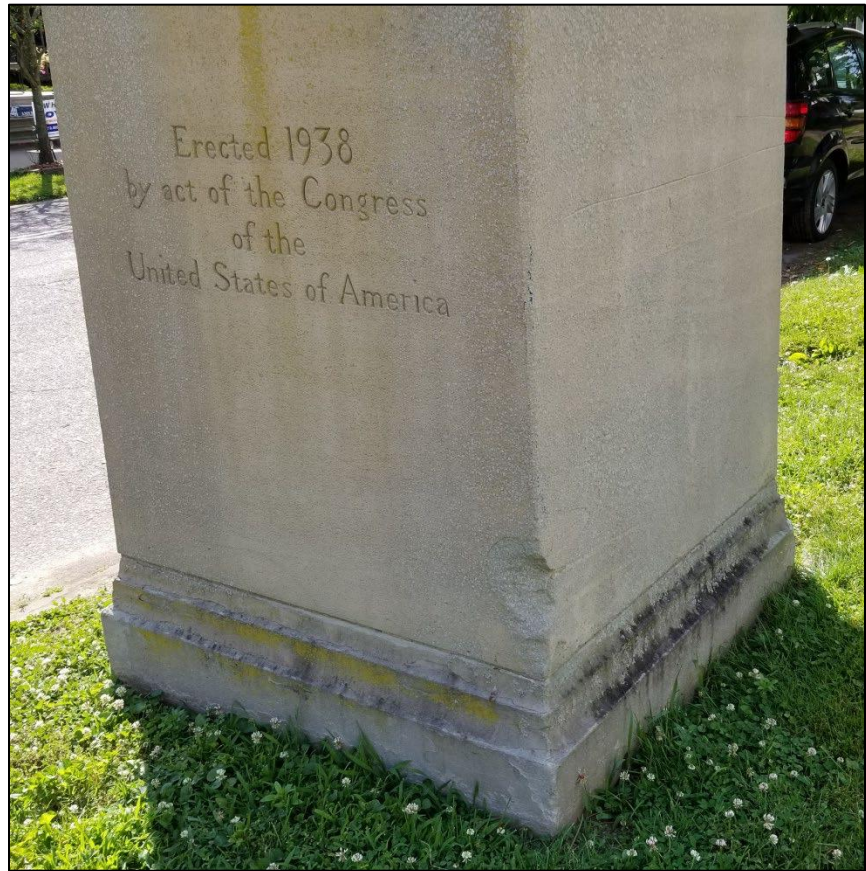
Photo 45: Detail of the southeast of the northeast pylon showing the loss due to impact damage. Note also the biological growth on the bottom profile block, which has areas of peeling and loss.
